## EAGLAIS NA H-AOIDHE CHURCH

### REPORT ON STORM DAMAGE AND THREATS FROM THE SEA

STATUS FOR APRIL 2015

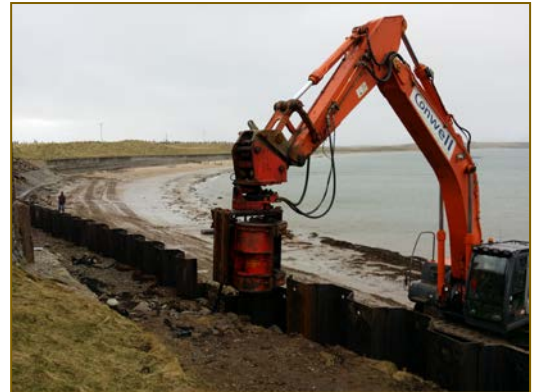
1. SPECIALIST PILE DRIVING MACHINE

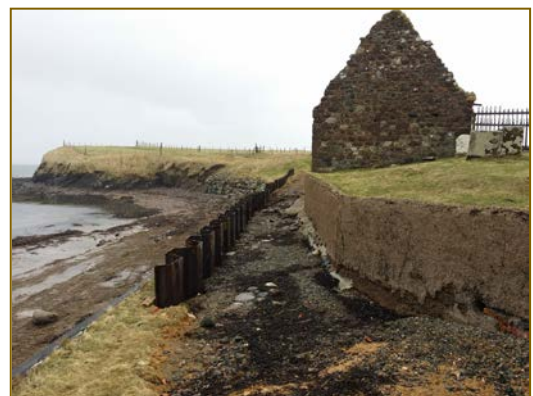
2. SHEET PILES

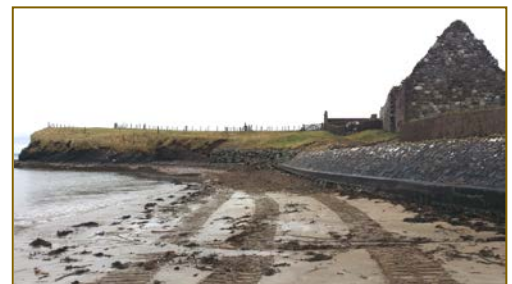
3. VIEW ON UNDERMINED CONCRETE TOE OF THE REVETMENT ALONG THE CHURCH AND LANDSLIP

It is undermined, sunken, bossed, avalanching, hollowed out, cracked and holed, allowing water and erosive forces to get behind it. This is certain to have begun a process of further change and weakening of the physical condition of the longstanding sandy soft peaty subsoil layers which hold up the church. This drove the need for the urgent steel piling measures. The worn back wedge of ground left holding up the corner of the church simply cannot be further exposed to destabilising changes in robustness and composition.

The revetment was not very strong by engineering standards to start with. It is basically tapered stones set fairly neatly in cement mortar but relying for stability mainly on their own weight, intact joints and being knitted into the gravel and sand underneath. When storm water and air get underneath and behind however they either lift up or lose support through erosion; either way they "buckle" and crack.

The stones were held against sliding down the slope by a strong toe of concrete keyed into the beach. However this is now being undermined as the beach level gets progressively lowered. Erosion of the sandy gravel underneath which the toe sits on is very apparent. If the toe were to rotate further, all the stones will slide into the sea.

Basically the revetment has to be rebuilt or heavily reinforced until this can be done. An engineered method must be found very soon.

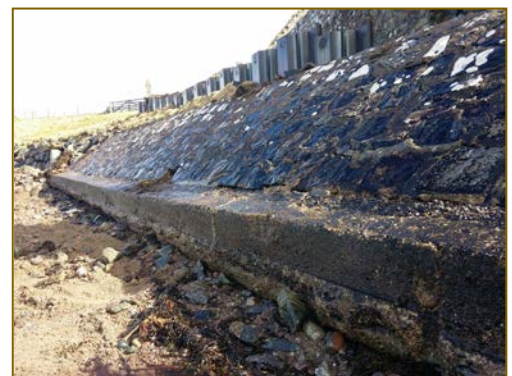
4. ANOTHER VIEW ON THE UNDERMINED TOE AND VOIDED AND BULGING ARMOUR STONE REVETMENT

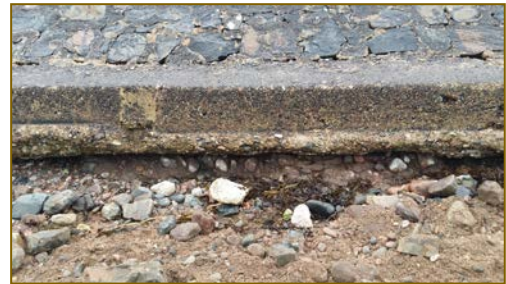
The stone revetment has collapsed completely in two areas and is now failing in between them. The loose ground behind it has been carried away leaving some dangerous vertical faces liable to collapse and causing injury. The toe is still there but is damaged.

5. UNDERMINED CONCRETE TOE, ALSO VISIBLE VOIDS IN THE STONEWORK

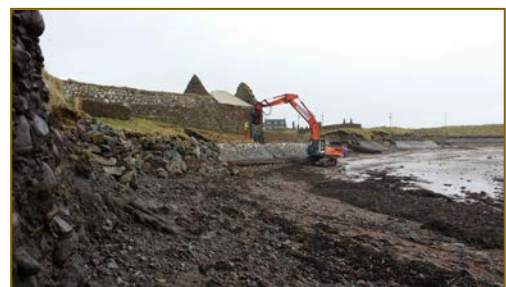
6. LANDSLIP IN THE EAST PART OF THE REVETMENT.

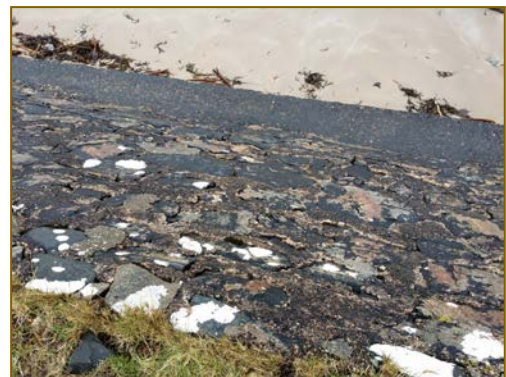
7. BULGING AND VOIDED STONEWORK

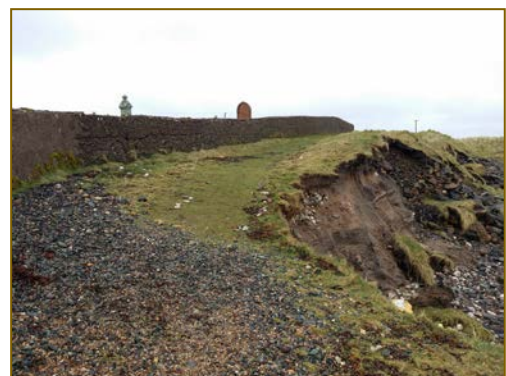
8. SEVERE LOSS OF GROUND WEST OF THE CHURCH CAUSING SERIOUS PUBLIC SAFETY ISSUE; ALSO THIS IS AREA OF OUTSTANDING ARCHAEOLOGICAL IMPORTANCE

The severity of the damage at these two areas serves to illustrate the weaknesses in the revetment. The installed piles should minimise a risk of such a disaster at the church but the erosion must not be allowed to take down more of the revetment anywhere.

With regard to safety, we had put up marker tapes and recommended some temporary shoring but these cannot be treated as a long term solution and safety needs to be enforced by the Council.

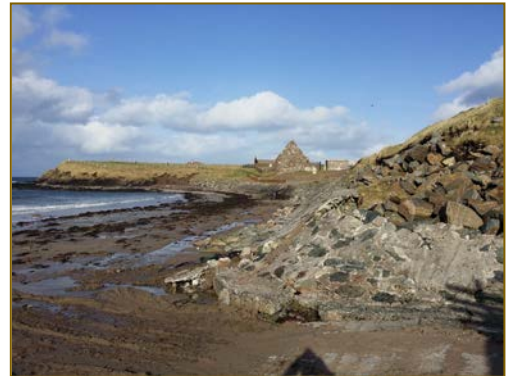
9. DAMAGE TO SIDE OF SLEEPWAY

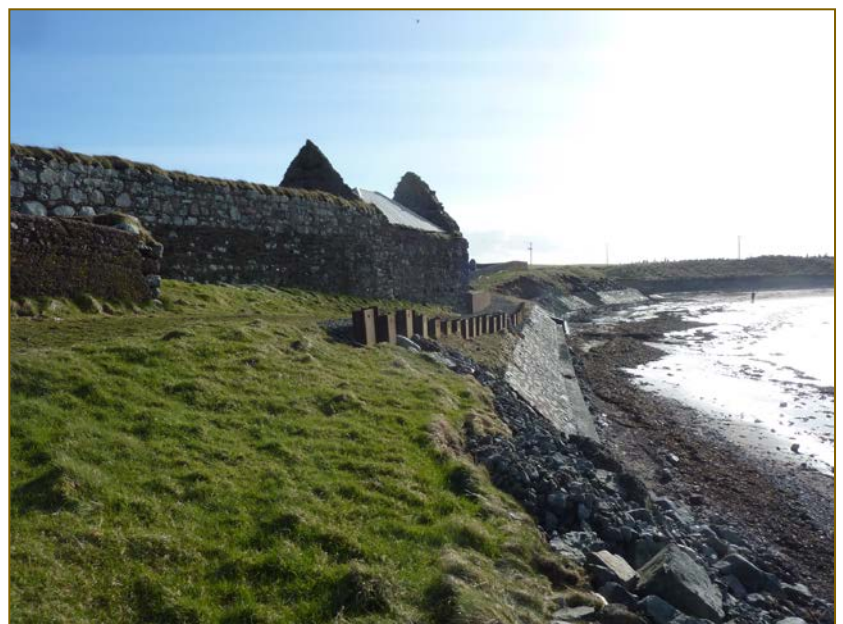
10. OVERALL VIEW OF THE COASTLINE SHOWING ALL THE AREAS OF DAMAGE

In the past few months huge storms have scoured out two very large voids from the banking to the west of where the graveyard burn outfalls to the sea. In parallel with this, the full length of the revetment itself was battered again and is now collapsing with voids beneath and behind it causing cracks in its face and subsidence. Its foundations are directly undermined as the beach itself has dropped a couple of feet since it was built. All this has also been an obvious and direct threat to the church for many years. The 40metre long barrier of 5metre high steel sheet piles have had to be installed to prevent subsidence of the Church's foundations.
