**conservation project**

**EAGLAIS NA H-AOIDHE  
ST COLUMBA'S UI CHURCH  
AIGNISH, ISLE OF LEWIS**

**CONSERVATION PROJECT**

**JULY 2013**

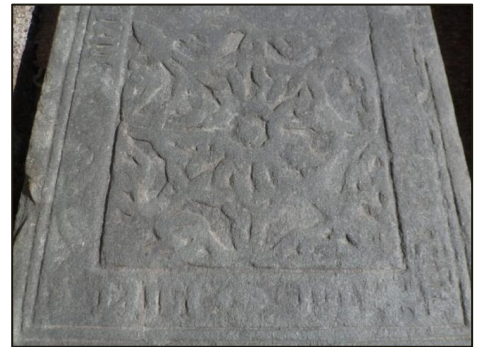
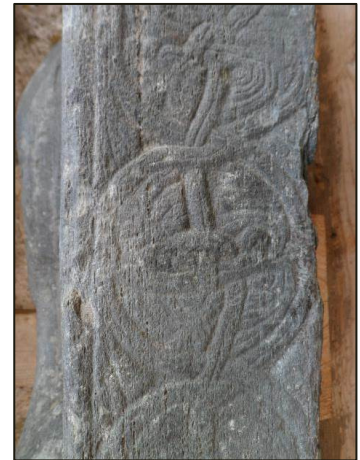
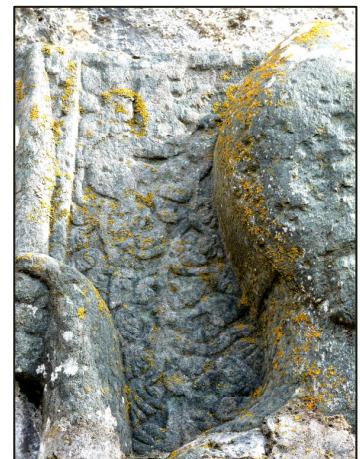
PHOTO SHOWING INTRICATE  
DECORATION OF MARGARET MACKINNON  
AND RODERICK MACLEOD SLABS

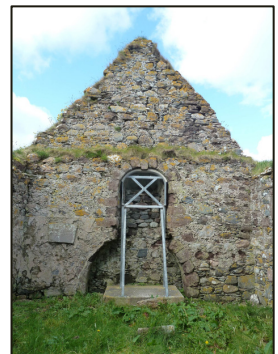
VIEW ON THE WEST GABLE OF WEST CHAPEL  
PRIOR TO PHASE 1 CONSERVATION – METAL  
SUPPORTING SYSTEM WAS LATER REMOVED

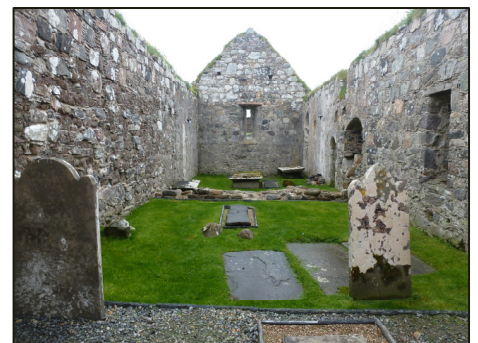
COMPLETE WORKS AT THE CHURCH VIEW  
TOWARDS EAST

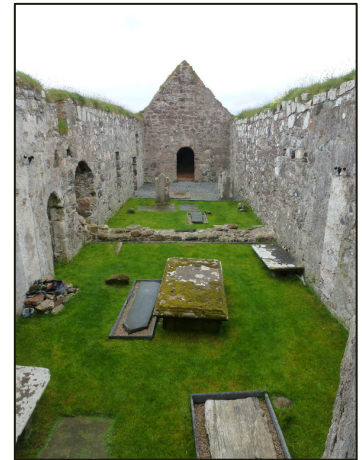
COMPLETE WORKS AT THE CHURCH VIEW  
TOWARDS WEST

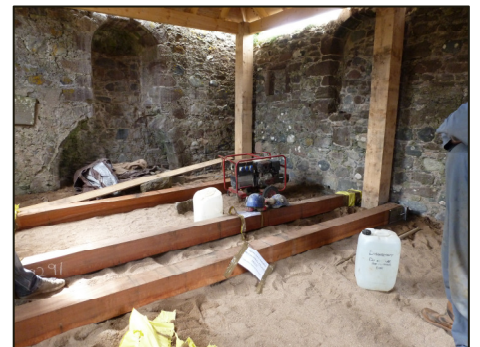
INSTALLATION OF TIE/STRUTS SYSTEM AT WEST  
CHAPEL

- In 2012, as part of the Phase 1 Conservation Works a tying/strutting system was installed in the foundations of West Chapel to improve its structural performance in consideration of the vulnerability created by the constant battering of the revetment and the incomplete state of the additional protection work.

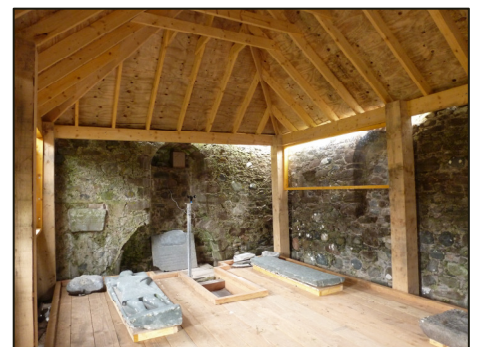
SLABS OF RODERICK MACLEOD (ON THE LEFT)  
AND MARGARET MACKINNON (ON THE RIGHT)  
UNDER THE CANOPY

The temporary protective canopy, although slightly adapted for the stones, in its current state, cannot be treated as a long term solution.

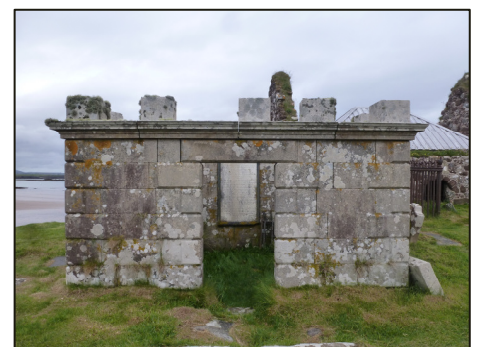
Both structures require extensive consolidation and partial rebuilding of the wallheads. The majority of the ashlar stones to do this can be recovered as they fell after being displaced by vegetation. It is anticipated that some conservation work should be done to the stone monument.

ONE OF THE MAUSOLEUMS CONTAINING  
COLONEL COLIN MACKENZIE'S MONUMENT

The cost for the masonry works and conservation works to the Mausoleums is anticipated to be £55,000 + VAT. This includes the professional fees for the design and site supervision, and stone conservation of the monuments in situ. This conservation work can be carried out as a separate phase of work
