## ST COLUMBA'S CHURCH

AIGNISH

LEWIS

## ARCHAEOLOGICAL WATCHING BRIEF

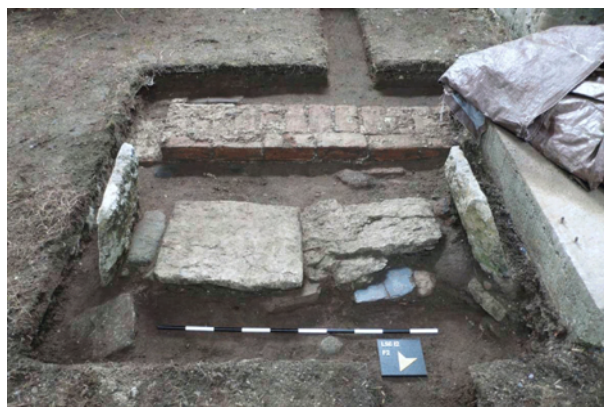
Plate 3 F2 looking south (scale 1.0m)

The area of investigation further revealed stone-built feature F2 which could be identified as a stone grave cover. The feature consisted of an upright stone slab at the western and eastern ends which were visible as upstanding slabs prior to intervention (Plate 3). These slabs enclosed a linear arrangement of slabs laid flat with the whole measuring c.1.3m west-east x 0.60m north-south. The slabs were rough, of variable geology and included a slate roof tile.

Further investigation of F2 revealed a somewhat *ad hoc* grave marker consisting of two small kerbs set to the west and east ends of the grave with a stone slab cover and no more formal memorial. Both burials are likely to post-date the disuse of St Columba's Church in 1829, perhaps once the chapel had become roofless, and after which time the area may have been used as part of the broader burial ground. Burial within churches, with the exception of purpose built burial aisles, ceased at or shortly after the Reformation and the upstanding nature of the kerbs forming F2 suggest they were erected after the building ceased to be used for worship.

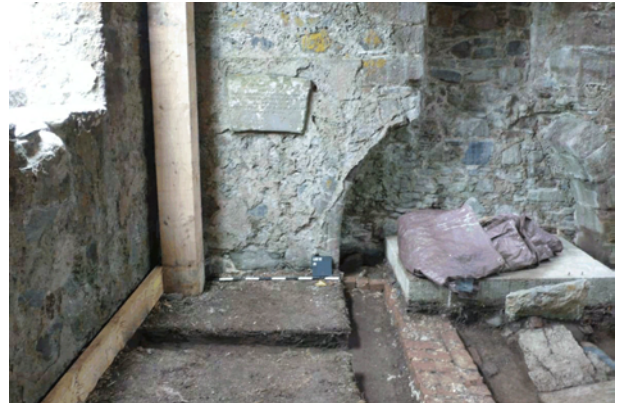
**Plate 4 Wall plaque and plaster adjacent to F1 (scale 1.0m)**

Further investigation of F1 along with inspection of the adjacent extant walls suggest that the footing may have formed part of a small burial enclosure position within the southwest corner of the west chapel. A wall plaque and an area of vestigial wall plaster survive on the west wall and suggest a nearby interment (Plate 4). F1 may represent the base for a walled or railed burial enclosure.
